Test Report

To	Metforce Pty Ltd 86 Furniss Road Landsdale WA 6919	Report No.	MTS-19312 METF
Order No.	PAUL1	Issue Date	4/10/2014
		Test Date	1/10/2014

Test Item(s) One (1) only Frameless Glass Balustrade with 17 x 18mm Channel Handrail supported on 2 x Square Core Drilled and 2 x Square Deck Mounted spigots.

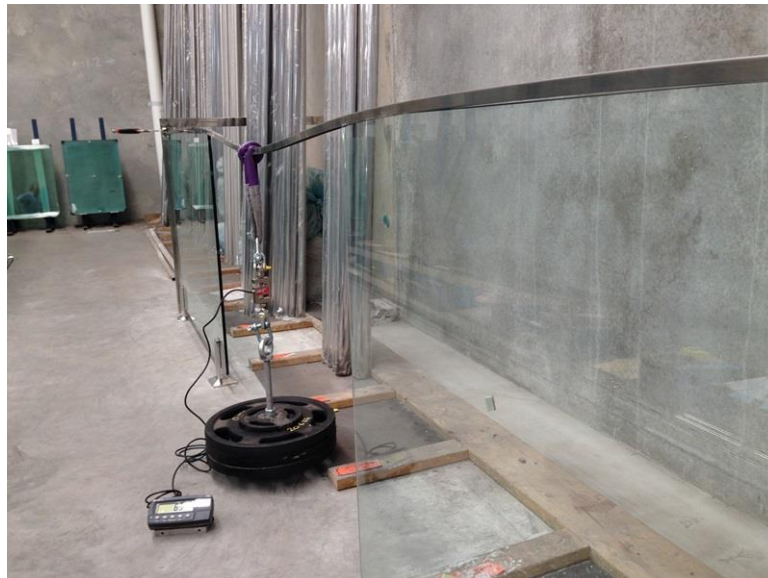
Specimen ID	Test Load (N)	Observations	Assessment
Top Rail Downwards Test	600	No signs of fracture or loosening.	COMPLIES

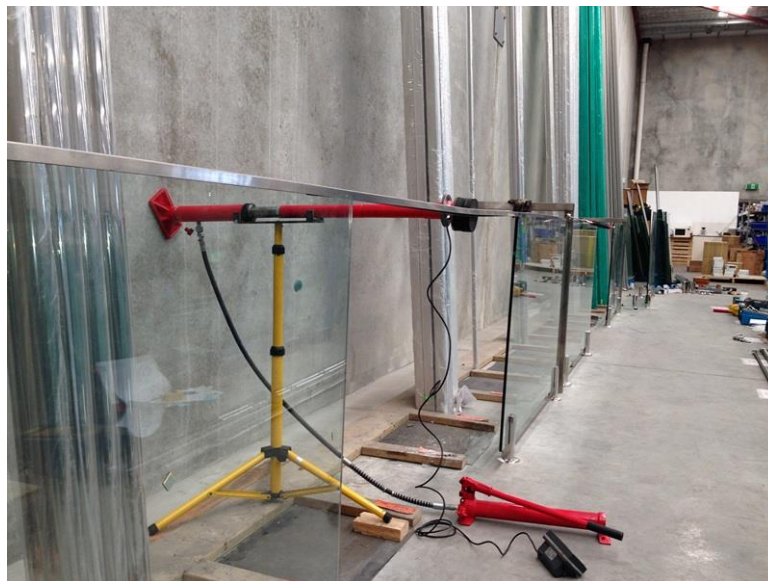
Top Rail Outwards Test

17 X18 Channel under the test
 No signs of fracture or loosening.

COMPLIES
