Test Report

To	Metforce Pty Ltd 86 Furniss Road Landsdale WA 6919	Report No.	MTS-19314 METF
Order No.	PAUL1	Issue Date	4/10/2014
		Test Date	1/10/2014

MTS Metallurgical Testing Services was engaged to perform load tests on a frameless glass balustrade to the requirements of AS/NZS 1170.1 - 2002.

Test Item(s) One (1) only Frameless Glass Balustrade with 25 x 50mm Rectangle Slotted Tube Handrail supported on 2 x Square Core Drilled and 2 x Square Deck Mounted spigots.

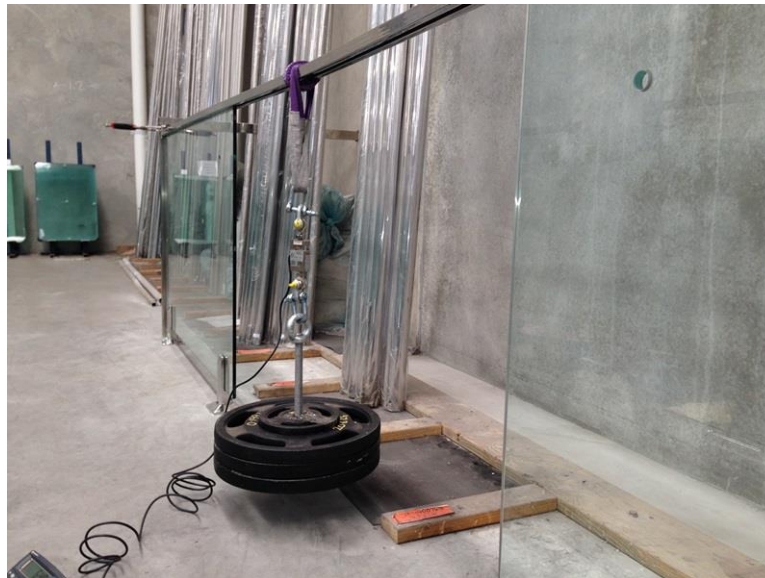
Specimen ID	Test Load (N)	Observations	Assessment
Top Rail Downwards Test	600	No signs of damage or loosening.	COMPLIES

25X50 Rectangle slotted tube under the test
 No signs of damage or loosening.

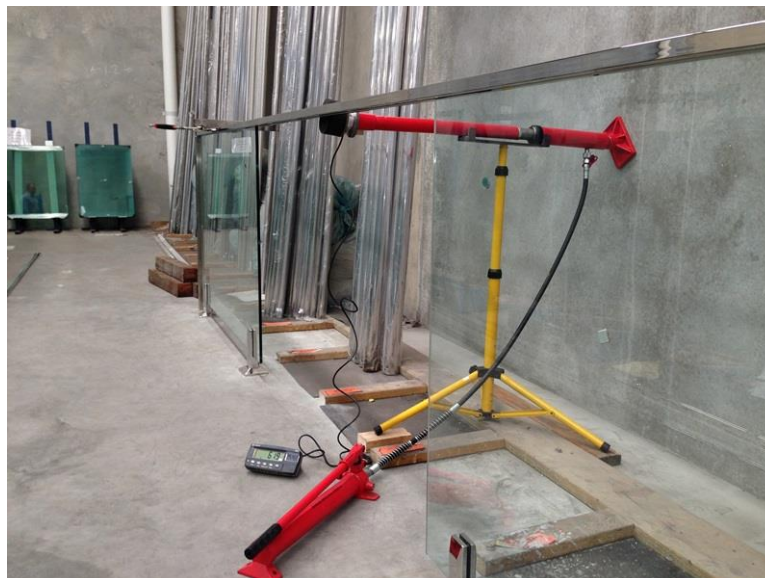
Top Rail Outwards Test

600

COMPLIES

25X50 Rectangle slotted tube under the test
