Test Report

To	Metforce Pty Ltd 86 Furniss Road Landsdale WA 6919	Report No.	MTS-19309 METF
Order No.	PAUL1	Issue Date	4/10/2014
		Test Date	1/10/2014

MTS Metallurgical Testing Services was engaged to perform load tests on a frameless glass balustrade to the requirements of AS/NZS 1170.1 - 2002.

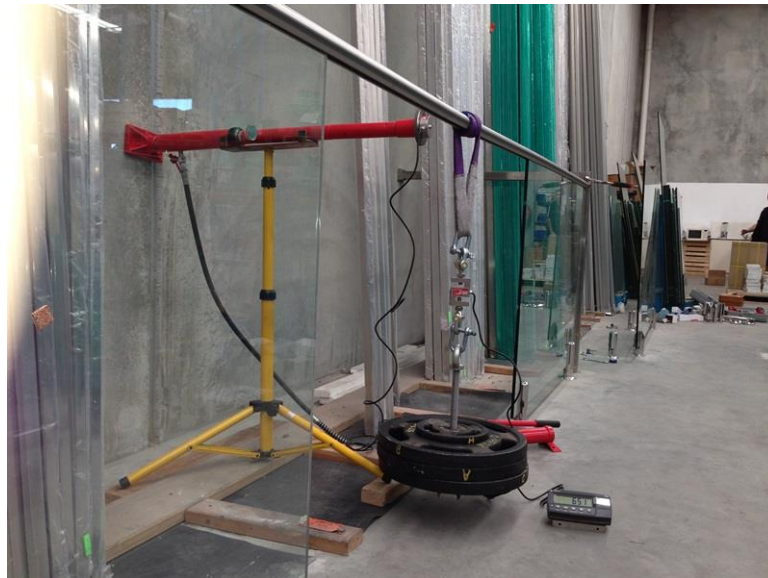
Specimen ID	Test Load (N)	Observations	Assessment
Top Rail Downwards Test	600	No signs of damage or loosening.	COMPLIES

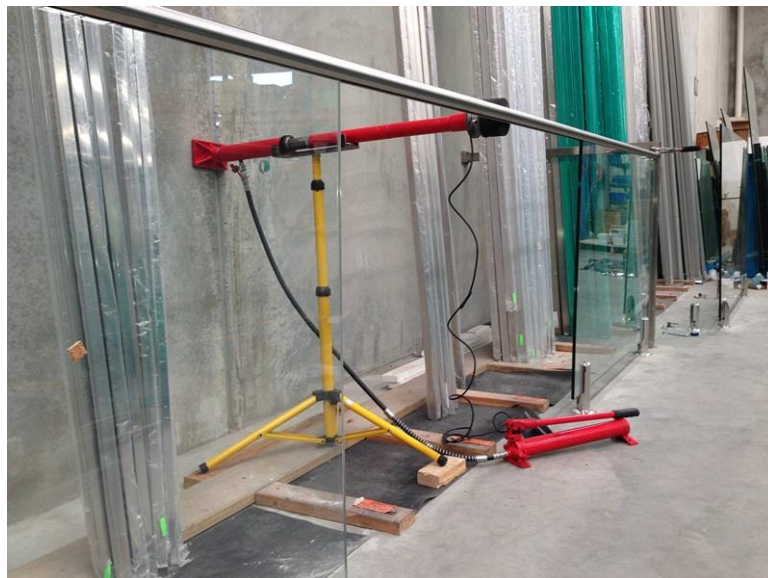
Top Rail Outwards Test

38.1mm round slotted tube under the test
 No signs of damage or loosening.

COMPLIES
