Test Report

To	Metforce Pty Ltd 86 Furniss Road Landsdale WA 6919	Report No.	MTS-19310 METF
Order No.	PAUL1	Issue Date	4/10/2014
		Test Date	1/10/2014

MTS Metallurgical Testing Services was engaged to perform load tests on a frameless glass balustrade to the requirements of AS/NZS 1170.1 - 2002.

Test Item(s) One (1) only Frameless Glass Balustrade with 50.8mm Round Slotted Tube Handrail on 2 x Round Core Drilled spigots and 2 x Round Deck Mounted spigots.

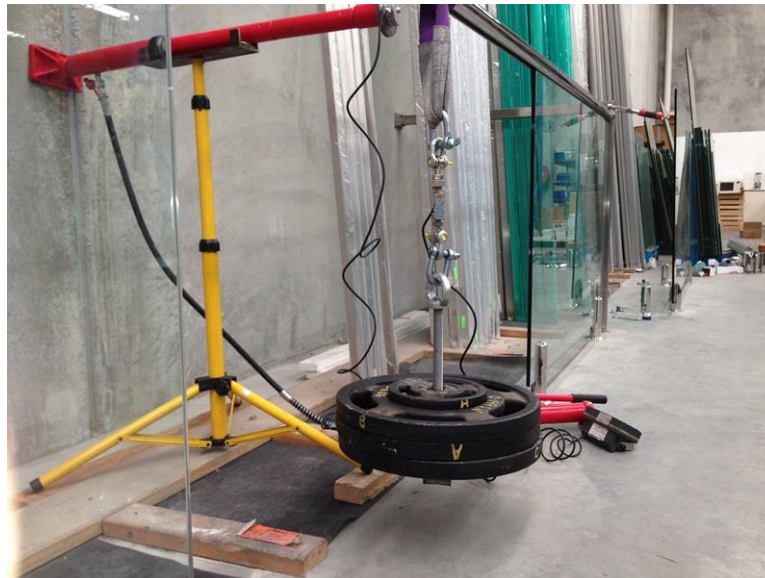
Specimen ID	Test Load (N)	Observations	Assessment
Top Rail Downwards Test	600	No signs of damage or loosening.	COMPLIES

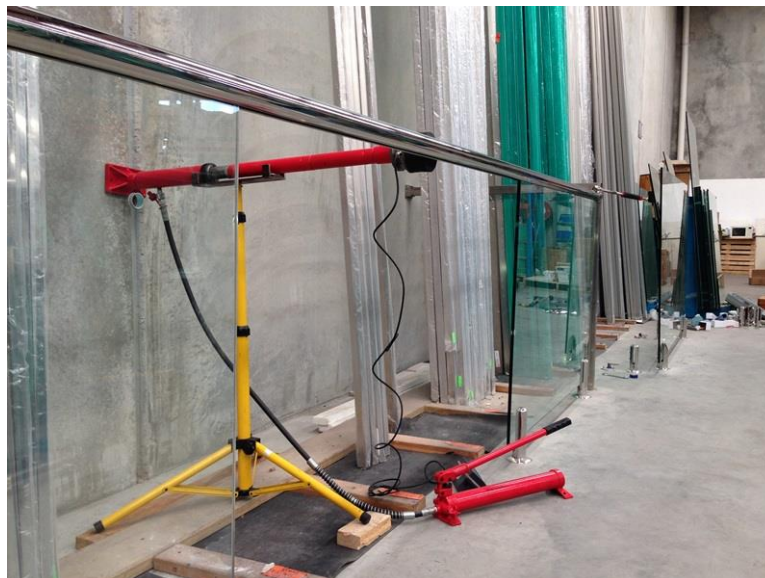
Top Rail Outwards Test

50.8mm round slotted tube under the test
 No signs of damage or loosening.

COMPLIES

50.8mm round slotted tube under the test
