Test Report

To	Metforce Pty Ltd 86 Furniss Road Landsdale WA 6919	Report No.	MTS-19311 METF
Order No.	PAUL1	Issue Date	4/10/2014
		Test Date	1/10/2014

MTS Metallurgical Testing Services was engaged to perform load tests on a frameless glass balustrade to the requirements of AS/NZS 1170.1 - 2002.

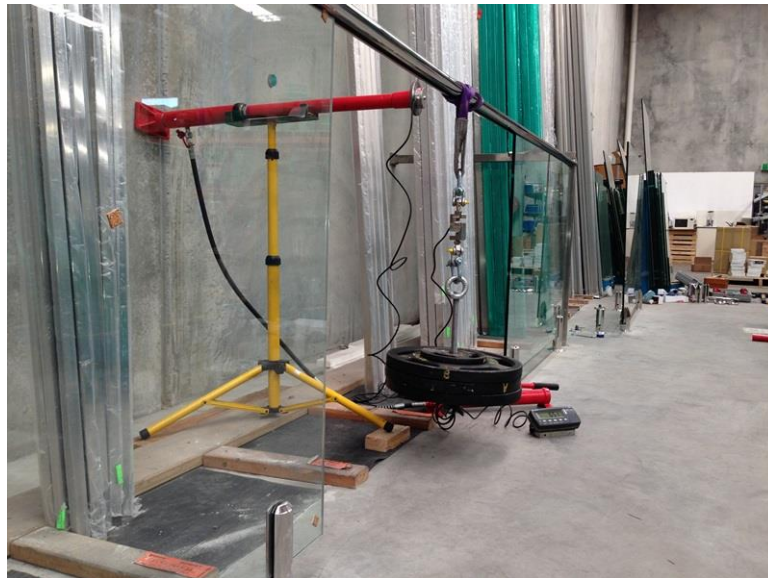
Specimen ID	Test Load (N)	Observations	Assessment
Top Rail Downwards Test	600	No signs of damage or loosening.	COMPLIES

60X40 oval slotted tube under the test
 No signs of damage or loosening.

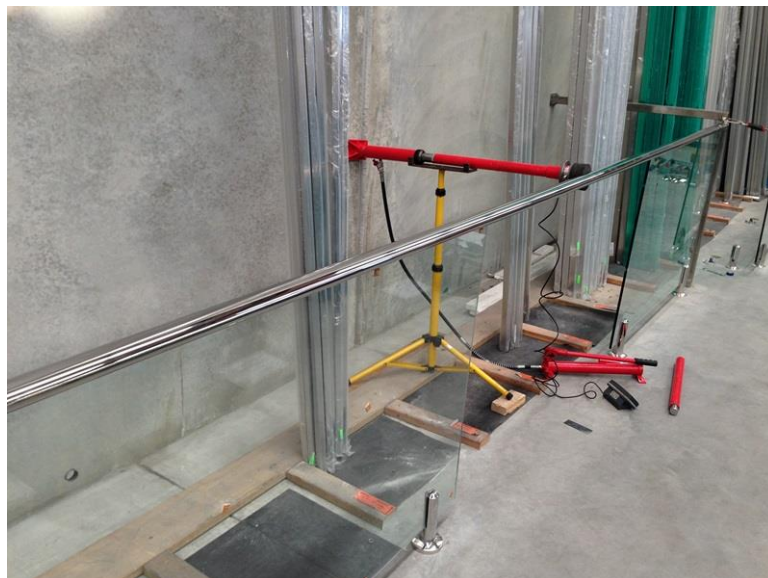
Top Rail Outwards Test

60X40 oval slotted tube under the test
