Test Report

To	Metforce Pty Ltd 86 Furniss Road Landsdale WA 6919	Report No.	MTS-19308 METF
Order No.	PAUL1	Issue Date	2/10/2014
		Test Date	30/09/2014

MTS Metallurgical Testing Services was engaged to perform load tests on a frameless glass balustrade to the requirements of AS/NZS 1170.1 - 2002.

Test Item(s) One (1) only Frameless Glass Balustrade with 25.4mm Round Slotted Tube Handrail supported on 2 x Round Core Drilled and 2 x Round Deck Mounted Spigots.

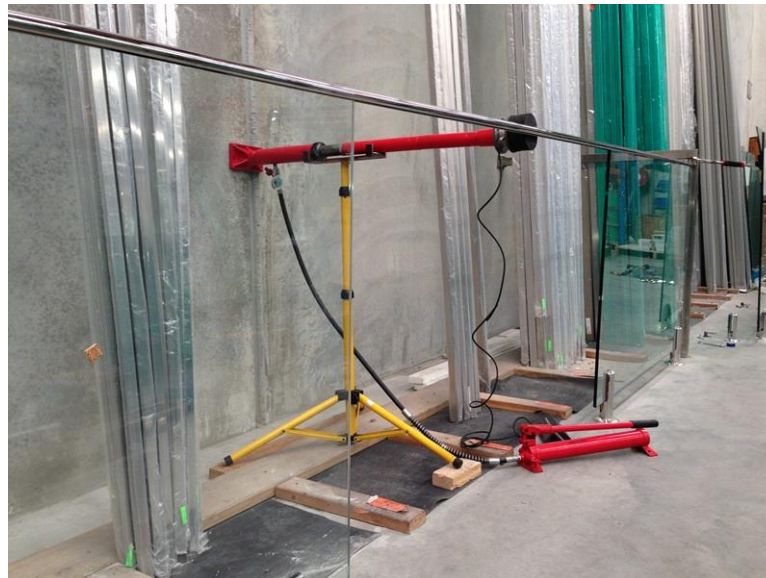
Specimen ID	Test Load (N)	Observations	Assessment
Top Rail Outwards Test	600	No signs of damage or loosening	COMPLIES

The test arrangement with 25.4mm round slotted handrail under the test.

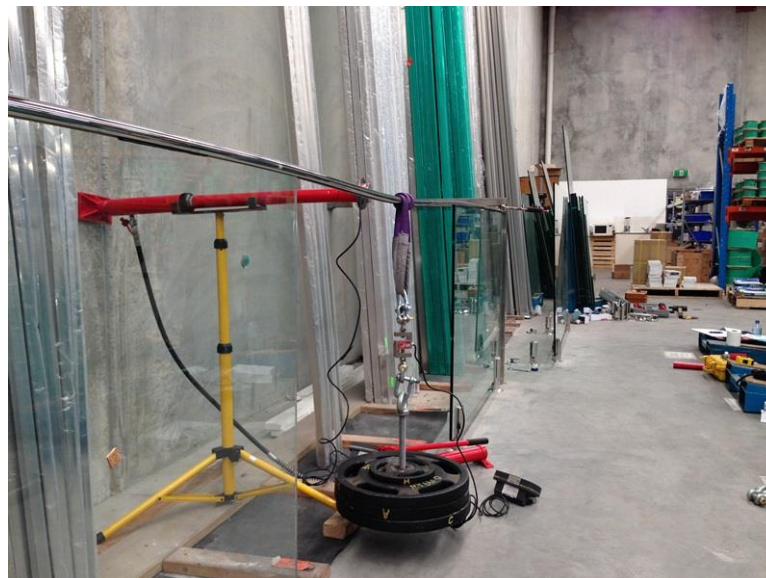
Top Rail Downwards Test	600	No signs of damage or loosening	COMPLIES
-------------------------	-----	---------------------------------	----------

25.4mm round slotted tube under the test
