Test Report

| To | Metforce Pty Ltd 86 Furniss Road Landsdale WA 6919 | Report No. | MTS-19304 METF |

MTS Metallurgical Testing Services was engaged to perform load tests on a toughened glass pool fence panel to the requirements of AS 1926.1 - 2012.

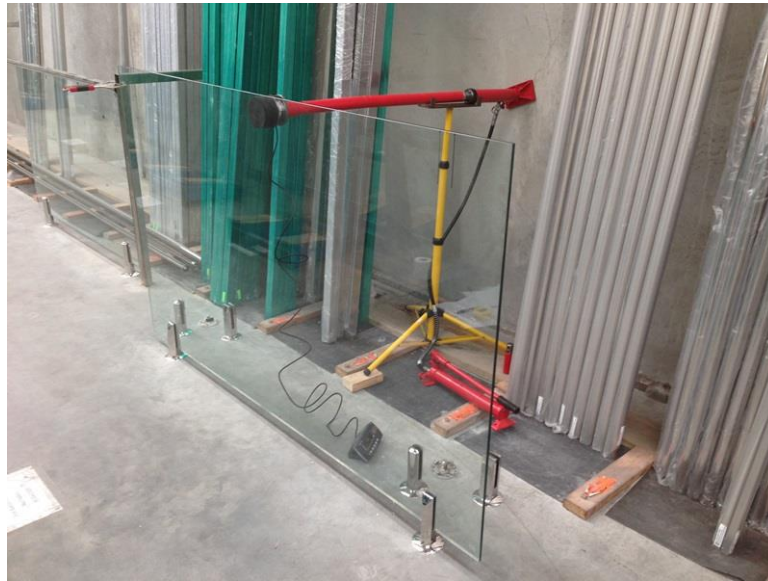
| Specimen ID | Test Load (N) | Observations | Assessment |
|---|---|---|---|
| 19304/01 | 330 | No signs of breakage, loosening or distortion observed. | COMPLIES |

Diamond Core Drilled spigots under the test
