Test Report

To	Metforce Pty Ltd 86 Furniss Road Landsdale WA 6919	Report No.	MTS-19121 METF
Order No.	PAUL	Issue Date	17/09/2014
		Test Date	16/09/2014

Test Item(s) Two (2) only Balustrade Standoff Fittings

Standard/Specification Client Specification (Based on the design requirements of AS/NZS 1170)

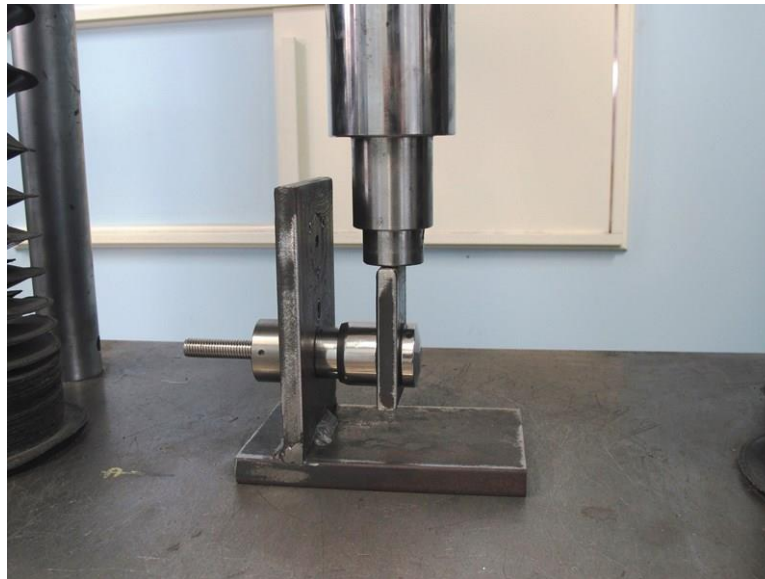
Specimen ID	Test Load (N)	Observations	Assessment
19121/1	5,500	No signs of cracking, distortion or any other failure. Load bearing capacity: >560 kgs.	NOT ASSESSED

The standoff fitting under the test

Load Test - STANDOFF 38ADJ

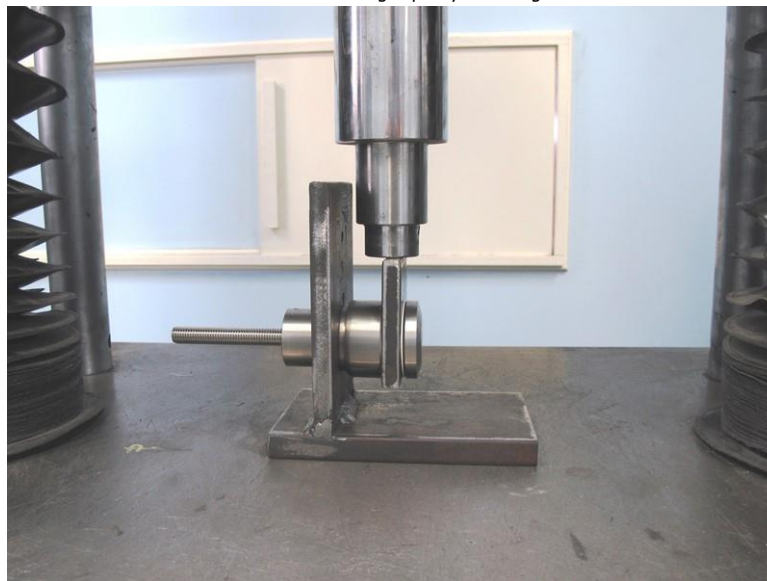
Specimen ID	Test Load (N)	Observations	Assessment
19121/2	5,500	No signs of cracking, distortion or any other failure. Load bearing capacity: >560 kgs.	NOT ASSESSED

The standoff fitting under the test

Load Test - STANDOFF 50ADJ
