MTS Metallurgical Testing Services
 ABN 54 122 133 331
 3/52 Cocos Drive Bibra Lake Western Australia 6163
 Tel 08 9418 6380 Fax 08 9434 1328

Test Report

Test Item(s) Three (3) only Wall Handrail Brackets

Load Test - WALLBRACKET

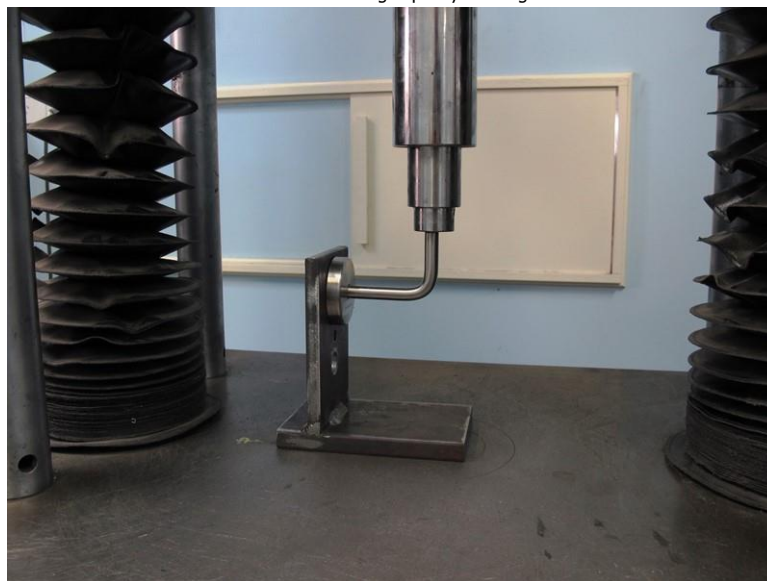
Specimen ID	Test Load (N)	Observations	Assessment
19120/02	1,150	The bracket failed by gradual distortion at the junction with the wall plate. Load bearing capacity: 117 kgs	NOT ASSESSED

Handrail bracket under the test

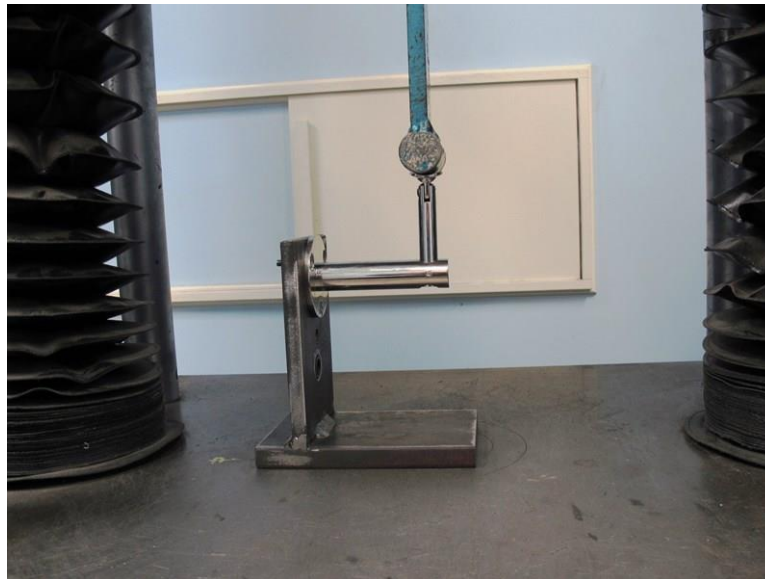
Specimen ID	Test Load (N)	Observations	Assessment
19120/01	1,000	The bracket failed by gradual slipping of the grub screw. Load bearing capacity: 102 kgs.	NOT ASSESSED

Handrail bracket under the test
